**ESTIMATED RESERVE REQUIREMENTS
FOR
EVERGREEN LAKES OF GWINNETT
HOMEOWNERS' ASSOCIATION**

Prepared by Huie Services, Inc.
April 28, 2017
© All rights reserved

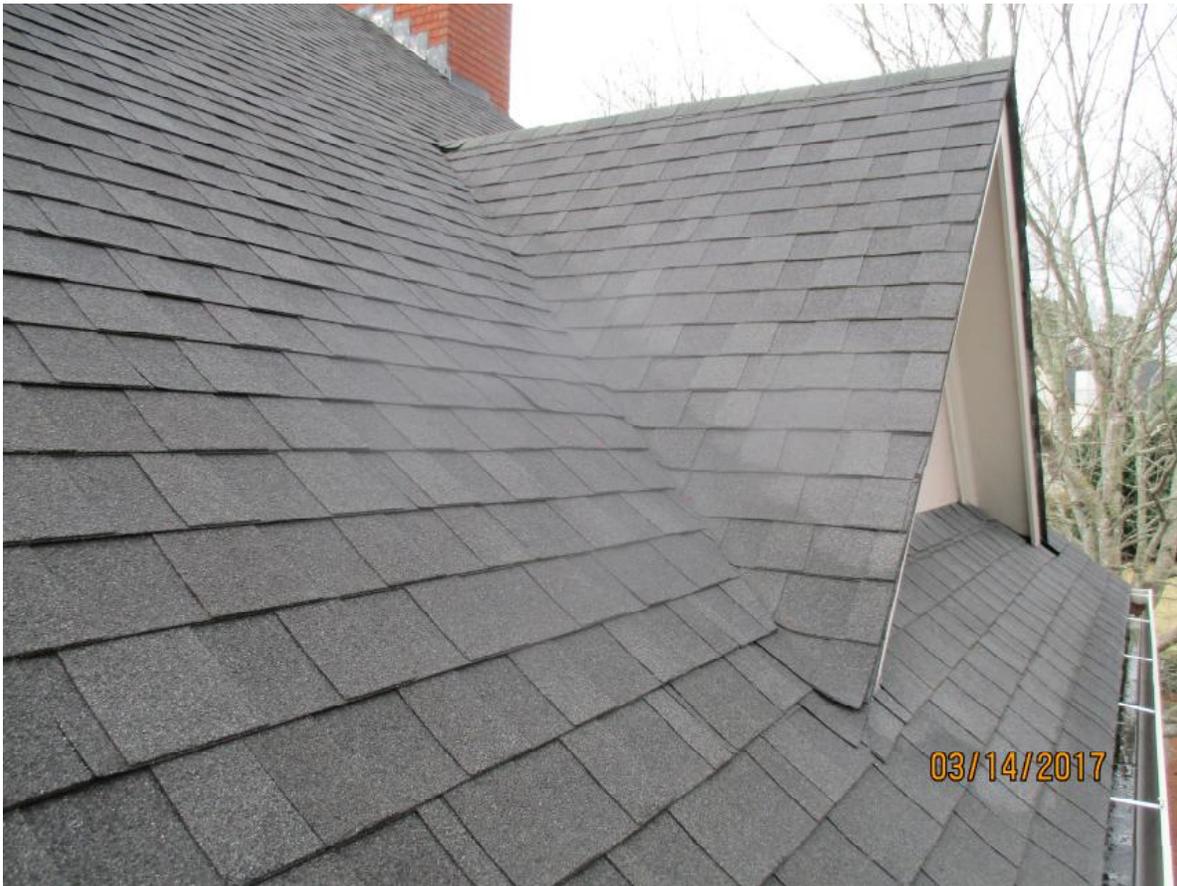
Roof Replacement - 27-year normal life. Architectural, fiberglass-reinforced asphalt shingles are installed on the Lakes clubhouse, tennis gazebo and pool equipment room roofs, along with the Crossings pool cabana roof. The roofing was replaced in 2009 due to hail damage. The shingles at all of the roofs are in good condition and aging normally.

When replacement is again necessary, it is recommended that you continue to use the "tear off" method, which means that the old shingles are completely removed before the new shingles are applied. While it is not essential that the old shingles be removed before applying a second roof, it does give a longer life to the new roof and also allows defects in the decking and flashing to be clearly seen. It is recommended that new step flashing be installed where the shingles abut the sides of the dormers and that metal flashing and a water-barrier membrane be placed in all roof valleys.

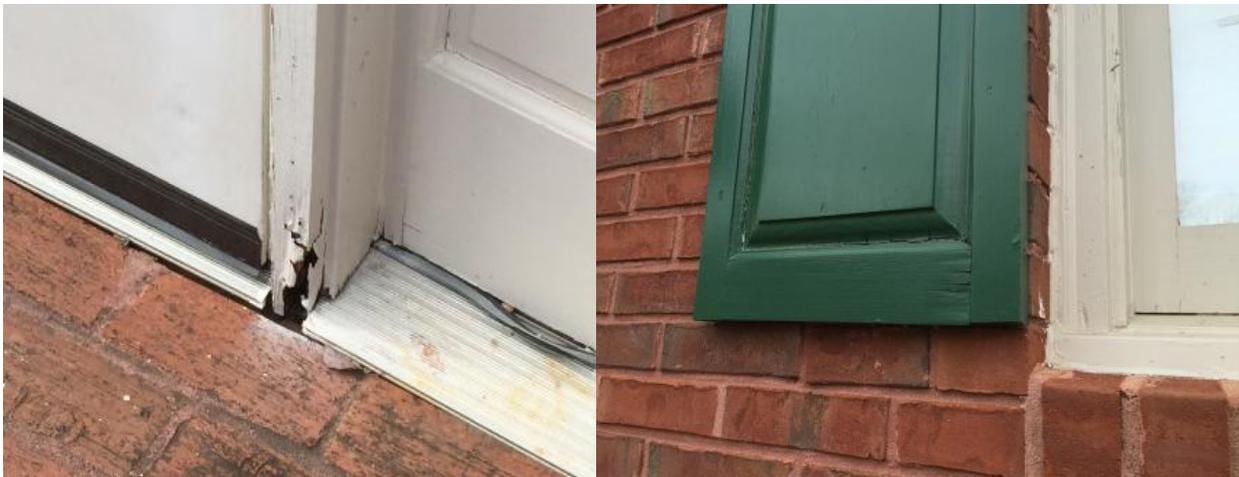
It was noted that some minor issues are appearing. At the Lakes clubhouse, there is some wood trim at the base of the exterior doors that is showing signs of rot, along with a shutter to the right of the front door.

When carpentry repairs are made, it is recommended that rot resistant lumber and fibered cement (i.e. Hardie) materials be used wherever possible.

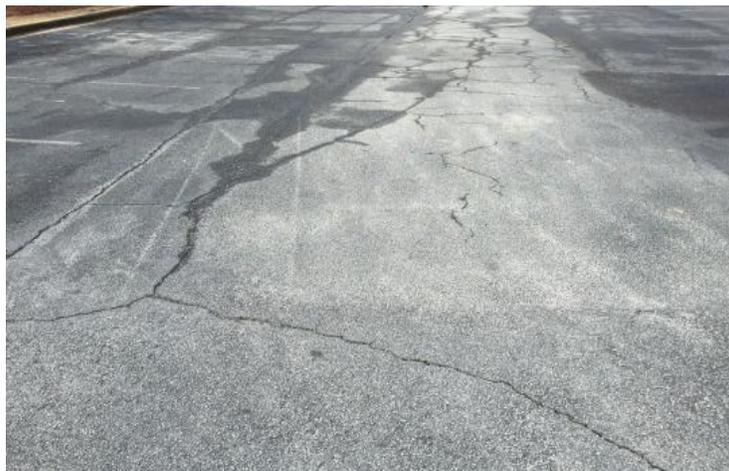
Asphalt Repairs/Seal-coating - 5-year normal life. As the asphalt pavement ages, repairs are necessary. The cost to have individual repairs made is very high on a per-square-yard basis. While certain repairs (e.g. after water or sewer lines are repaired in the driveway) must be made individually, it is more cost efficient to periodically have all needed repairs made at one time. With normal asphalt deterioration, problem areas develop as the large cracks intersect. The problem areas can be seen because they are cracking in a pattern known as “alligatoring” because of the resemblance to the pattern on an alligator’s skin. The price below includes the cost to repair asphalt areas equal to the cost to repave 5% of the total asphalt areas as shown in the previous category. Also included is the cost to stripe the parking area. As seen in the next photo, the striping has essentially worn away.

The cost below includes seal-coating. Seal-coating is primarily aesthetic but it does tend to extend the life of the asphalt by shielding it from ultra-violet sunshine. The cost would be about \$3600. The value of the additional life is probably worth what the seal-coating costs. That is, you should not expect to receive a cost benefit from sealing, but it will make the property more attractive. The cost to re-stripe the parking spaces is also included. The average time between sealcoating applications is 5 years. Most properties receive the maximum life from sealcoating with two coats, the first squeegeed to penetrate into cracks. If you decide to seal-coat, then the first application would be an Operating expense and subsequent applications would be Reserve expenditures. Also included is the cost to restripe both parking lots.

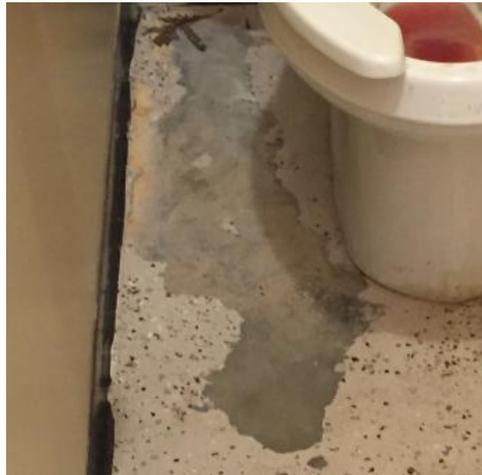
The floors for the pool restrooms at both the clubhouse and pool cabana are very similar. They all have a painted concrete floor, with signs of paint failure at all four restrooms. The photograph below shows one of the worst areas in the women’s restroom at the Crossings pool cabana.

The failure of the floor coating is a cosmetic issue so the timing of the remedial work and the type of remedial solution are at the discretion of the Association.

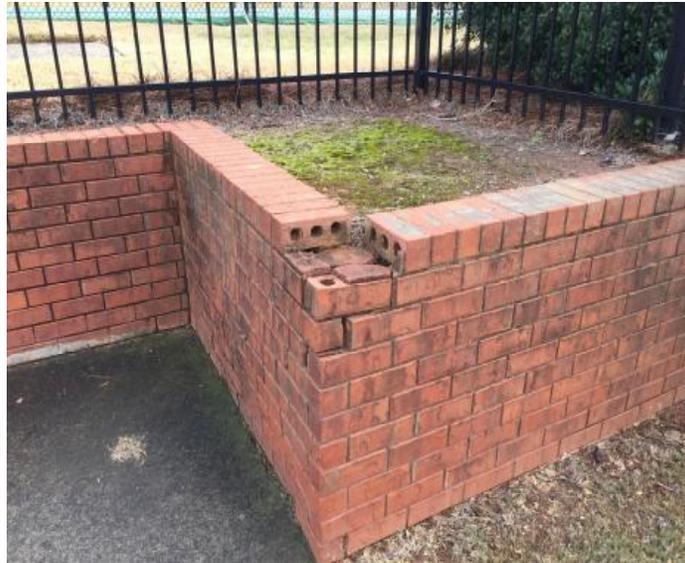
wall between the clubhouse pool and tennis courts, and the brick veneer at the clubhouse and pool equipment room. Most of these items appear to be in good condition, but areas are developing that will need attention, such as the brick retaining wall at the clubhouse pool shown in the next photograph.

These items were well constructed originally and should only be repaired by qualified workmen. This category assumes that you will accumulate various repairs to create a larger project to achieve an economy of scale. It is unlikely that one contractor will be qualified to repair all of the various types of masonry.

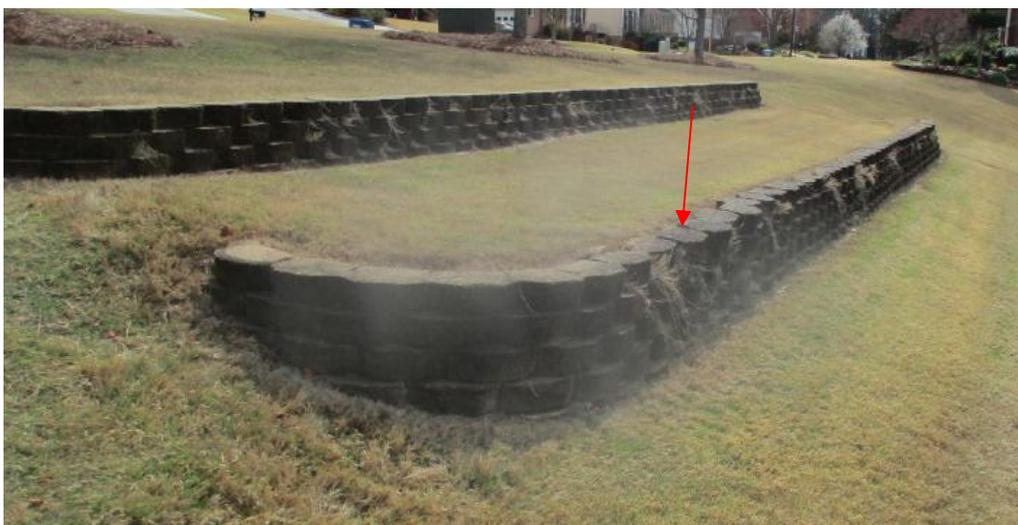
Also included is remedial work on the modular block retaining walls that were used to create terraces adjacent to the tennis courts. This type of modular block is generally used on smaller homeowner projects. Some remedial work is needed on the wall in the area indicated by the red arrow.

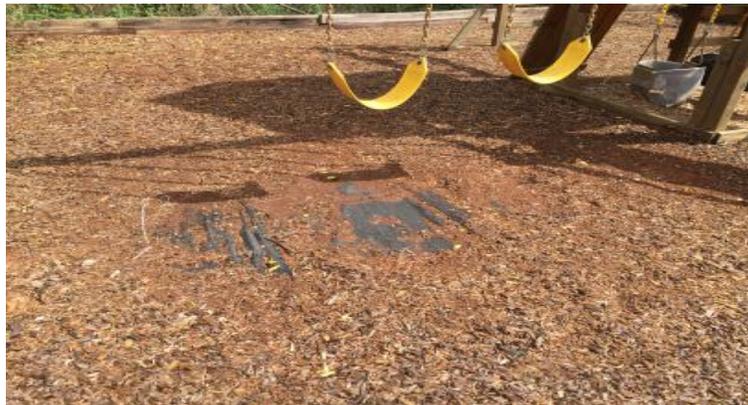
The playground mulch is low in many areas at both playgrounds. Replenishing this is considered an Operating expense except when the playground is renovated. Some Associations are changing to rubber mulch.

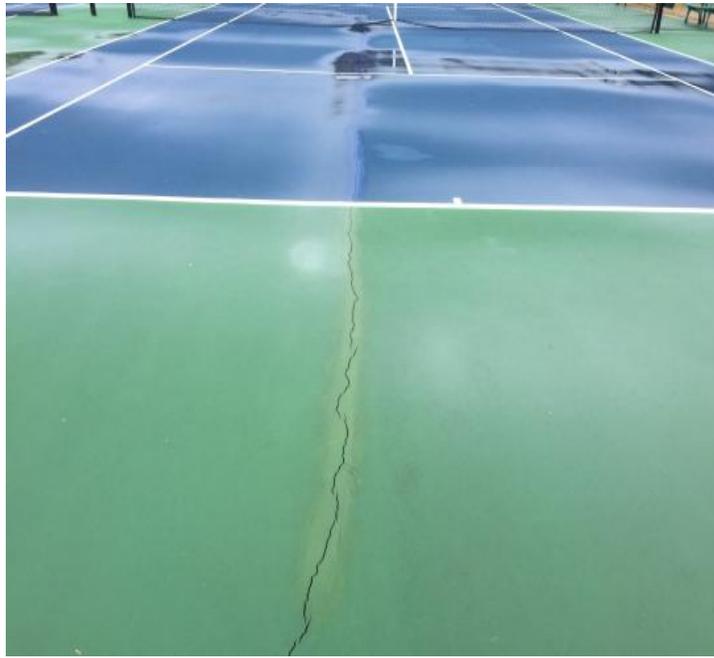
Tennis Court Surface - 5-year normal life. The playing surfaces of the 6 asphalt tennis courts are in good to fair condition. There are numerous cracks in the courts that are the long, straight cracks, which often occur along the side joints of the strips of asphalt. This type of cracking is commonly seen in tennis courts, and while annoying, they can be addressed each time the courts are resurfaced. The cracks will usually reappear within a year of recoating the surface of the courts. There is a method to fix the cracks on a longer-term basis (e.g. Armour and Guardian systems), but at \$12 to \$17 per linear foot for a 5-year guarantee, this would be an expensive process for courts with as many cracks as these.

The cost below is the cost to do the basic crack repair and resurfacing of the courts and replace the nets.

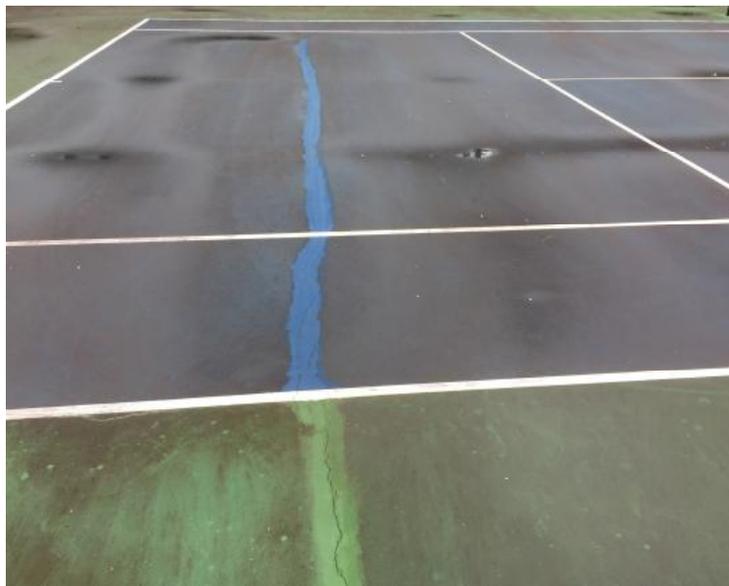
Crack repairs were made in the past to the Crossings courts, but the cracks have reappeared.

The four tennis courts at the Lakes were completely rebuilt in 2006 at a cost of \$60,000, and they were resurfaced in 2014. The cracks were repaired in 2015, 2016 (see photo above), and they are again planned for repair in 2017. These temporary repairs are considered to be an Operating expense.

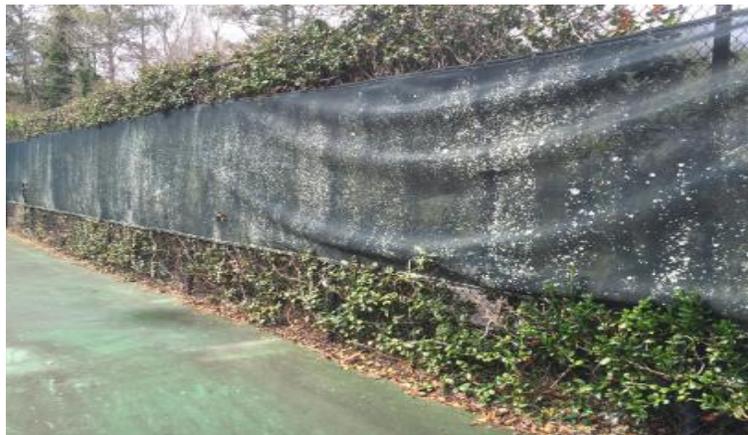
The photograph below shows the wind screen at the Crossing's courts. Wind screens are considered to be an Operating expense.
